Wallingford: The Castle and the Town in Context

BAR British Series 621
2015

THE LAST STAND: WALLINGFORD CASTLE AND THE CIVIL WAR. IMAGES AND INSIGHTS FROM ARCHAEOLOGY

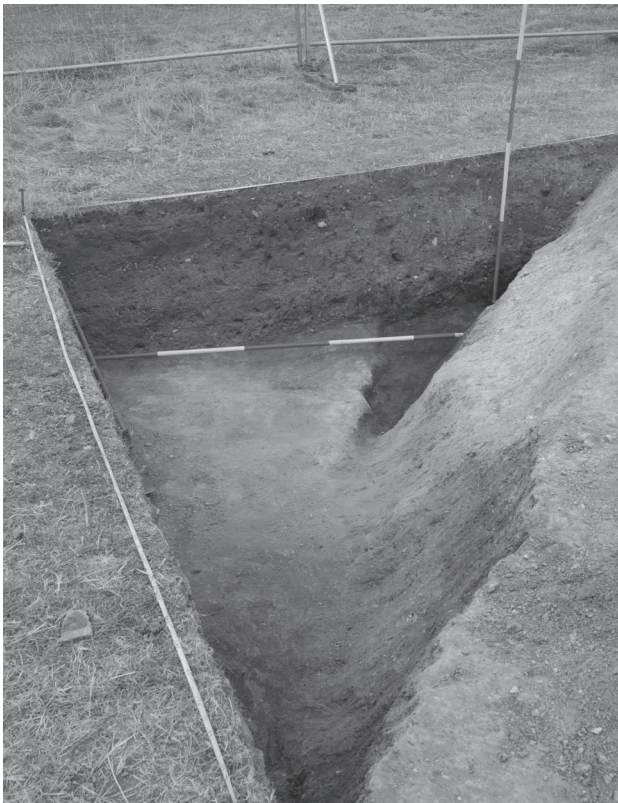
Figure 15.3 Trench 1 – the north-western angle of the Civil War bastion feature (Image © the Wallingford Burh to Borough Research Project).

Meadows (see Figure 15.2). Excavation rapidly confirmed the presence of a large north-facing artificial platform, surrounded by a substantial ditch (Figures 15.3 and 15.4). The earliest deposits comprised a homogenous series of medieval layers and dumped upcast from periodic cleaning or re-cutting of the castle ditch, these containing 12th- to 14th-century pottery; these deposits were sealed by the later platform but also cut by the ditch set around this to west, north and east. The platform itself was identified just 0.20–0.30m below the ground surface. Of 0.50–0.60m

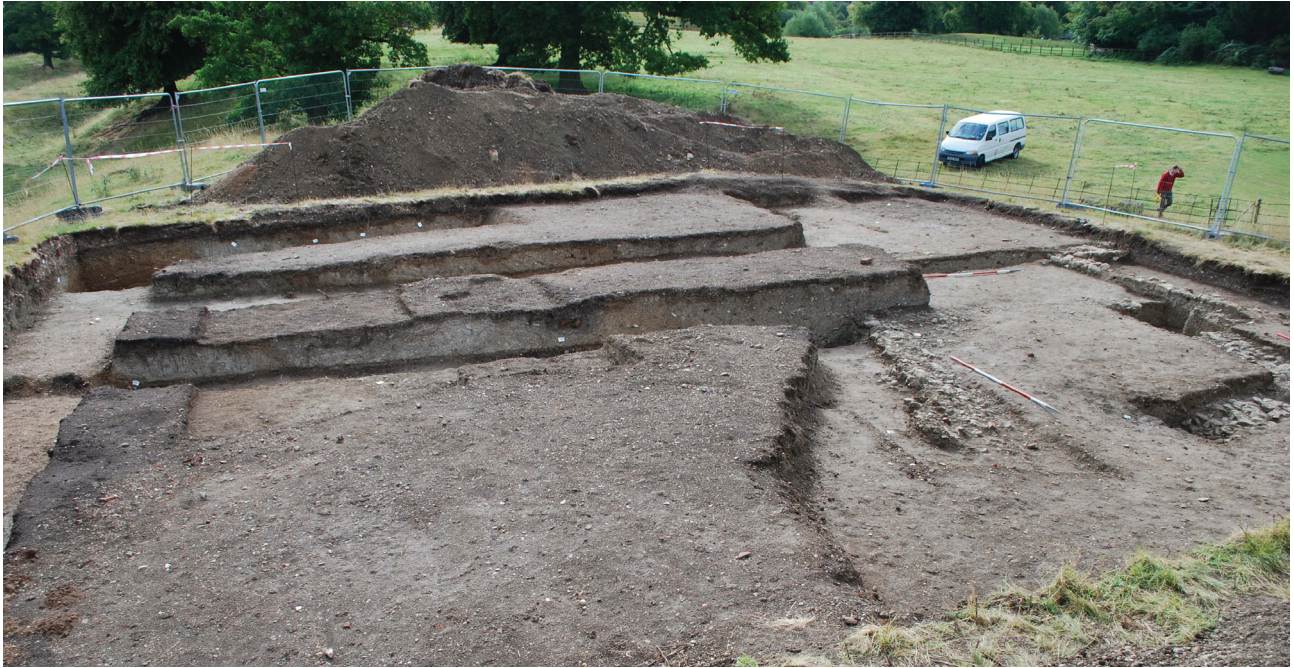
Figure 15.5 View looking east of Trench 10 after excavation, with rampart and related construction levels to left, and rubble spreads to the right (Image © the Wallingford Burh to Borough Research Project).

The results of the excavation (see Figure 15.5) were different from what was anticipated, adding less to our understanding of the medieval castle but more to our understanding of the mid-17th-century Civil War changes wrought on the castle spaces. Initial machine clearance included supervised slot cuttings down to recognizable archaeology in the northern half of the trench; much shallower clearance was required in the southern half, here coming down to scattered rubble deposits and a possible building. The latter survived as a set of crude walls, reusing older material, both chalk and sandstone, some well cut and others roughly worked only, and with limited bonding traces; in addition, clear traces of any internal surface or floor were lacking. The walls here overlay relatively shallow rubble and mortar spreads, whereas a more consistent and large rubble spread was traced to the north and north-west of the 'building'. Most probably the rubble relates to a phase of demolition or levelling, which was subsequently covered by imported sandy silt deposits, which featured noticeably mixed ceramic finds of 11th-through to 15th-century date. One possibility is that the material had been re-deposited here deliberately from clearance of the inner bailey ditch.

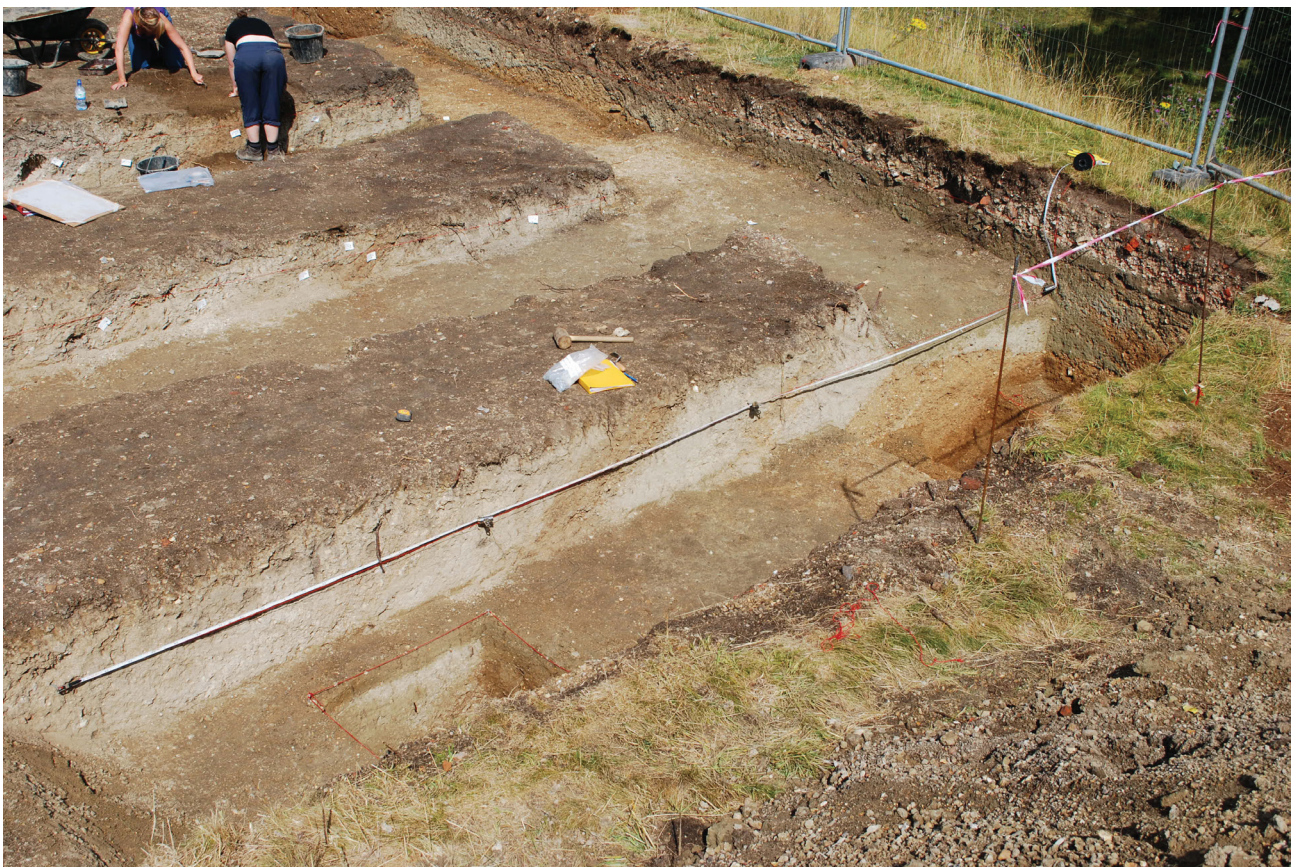
Figure 15.6 Trench 10 - photograph of the exposed make-up to the Civil War platform, consisting of the angled lines of marl-clay interleaved with sandy gravel deposits extending to the medieval rampart, a trace of which is exposed in the far right of the trench (Image © the Wallingford Burh to Borough Research Project).

The archaeology of the northern half of the trench revealed an even more substantial and diverse remodelling of the site. Two main deposit types were identified in the various north-south excavation slots, generally running as alternate angled bands laid from south to north: orange brown sandy gravel bands set over or overlain by firm, green-grey or brown-grey marl deposits (see Figure 15.6). The thicknesses of these deposits varied – from substantial

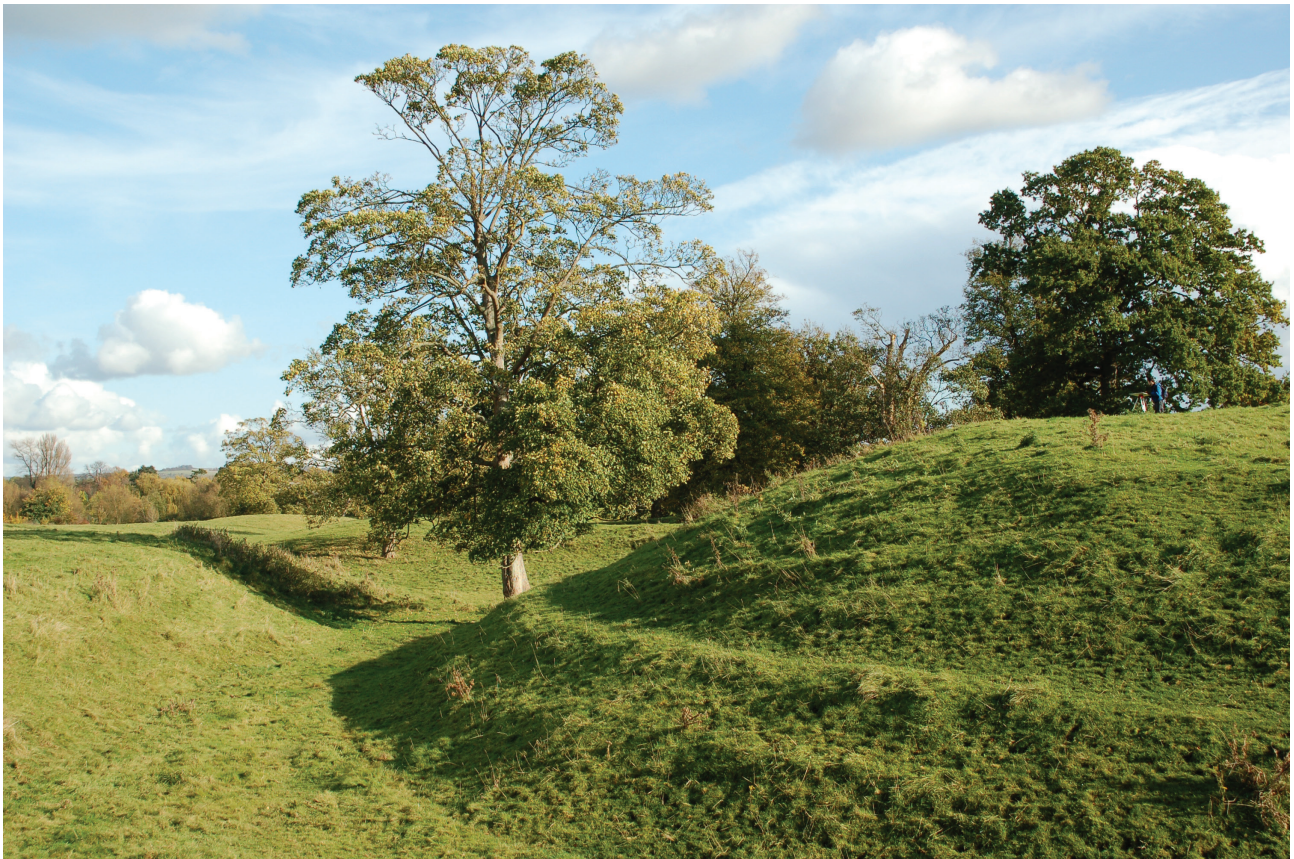
Figure 15.7 View from the west of the north face of the elevated 'barbican' zone, explored in Trench 10 in 2010 (Image © the Wallingford Burh to Borough Research Project)

of the bastion, pulling down the remnant facing stone wall and dragging down the top skin and flanks of the imported platform and materials. Potentially the debris from this is reflected in the stepped character of the earthwork on its western flank (Figure 15.7). Nonetheless, some clay pipe was recovered (30 fragments), many of which appear likely 17th-century in date, but with later finds too.

One can stress the very elevated setting of this barbican site (Figure 15.7) – deliberately raised higher for the Civil War conflict – and its highly strategic position in sight of the North Gate and controlling what we should assume was still the main entrance-way into the actual castle core (where, we can assume, was housed the entrenched garrison). It is valuable to re-quote the reference made in the documents of 1643 to the newly established defensive dispositions: ‘They have made very strong workes about the castle, and a double drawbridge at the entrance to the castle and two drakes [guns] planted there upon one carriage’. Potentially also, the substantial infill of the inner bailey ditch to the south-east of the barbican earthwork belongs to the Civil War works, perhaps undertaken in order to facilitate the drawing up of cannon or ‘drakes’ to this site. If correct, we have here notable archaeological testimony to the substantial works undertaken by the garrison and other labour to re-fortify Wallingford Castle; it offers a clearer recognition of not just strategy but, as importantly, the physical logistics to build and equip these positions. At the same time, the limited material culture we have gathered up puts us into some contact with the human presence that manned these stations; however, the restricted character of this material meanwhile helps us visualize far less a town, castle and garrison under constant siege but one which may have seen a much patchier series of confrontations – verbal as much as military.
